Port Authority of N.Y and N.J.
Litigation Sampling Program

Sample Area Data Sheet

Facility: World Trade Center Building: Tower 1

Description of Sampling Area: Elevator shafts' Zone I Local Cars.

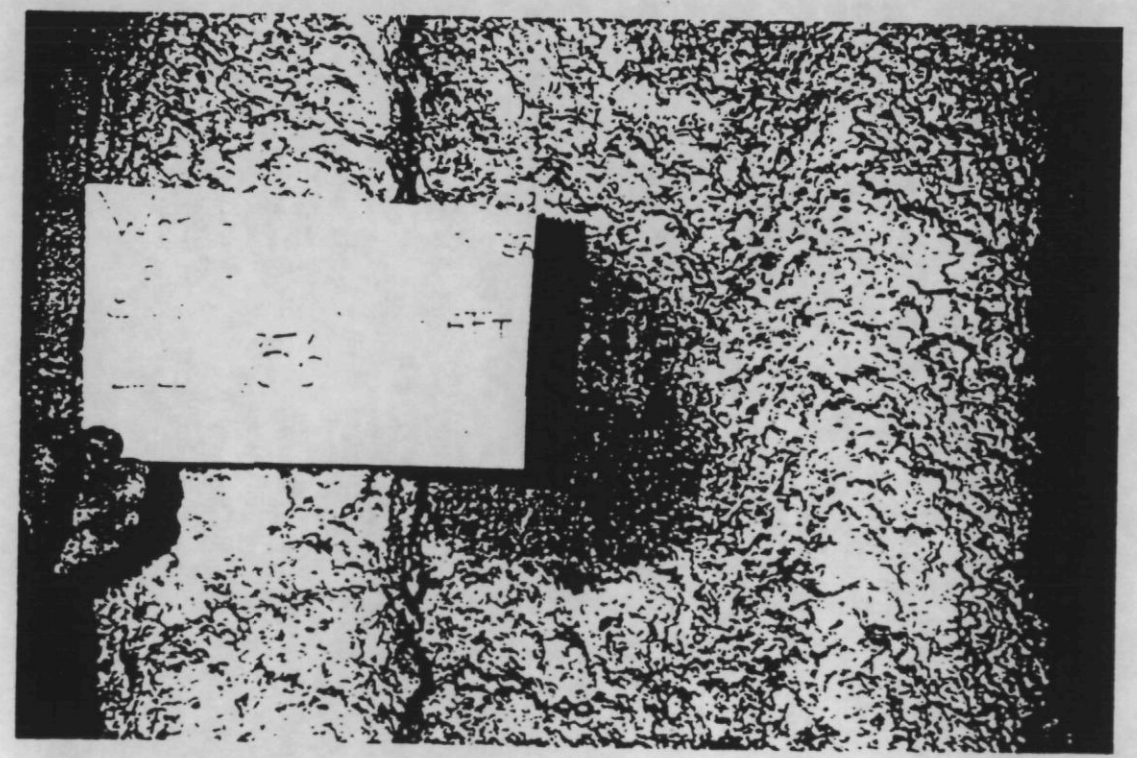
World Trade Center
Tower-1
Elevator Shaft
LL-756-WTC
12-16-91

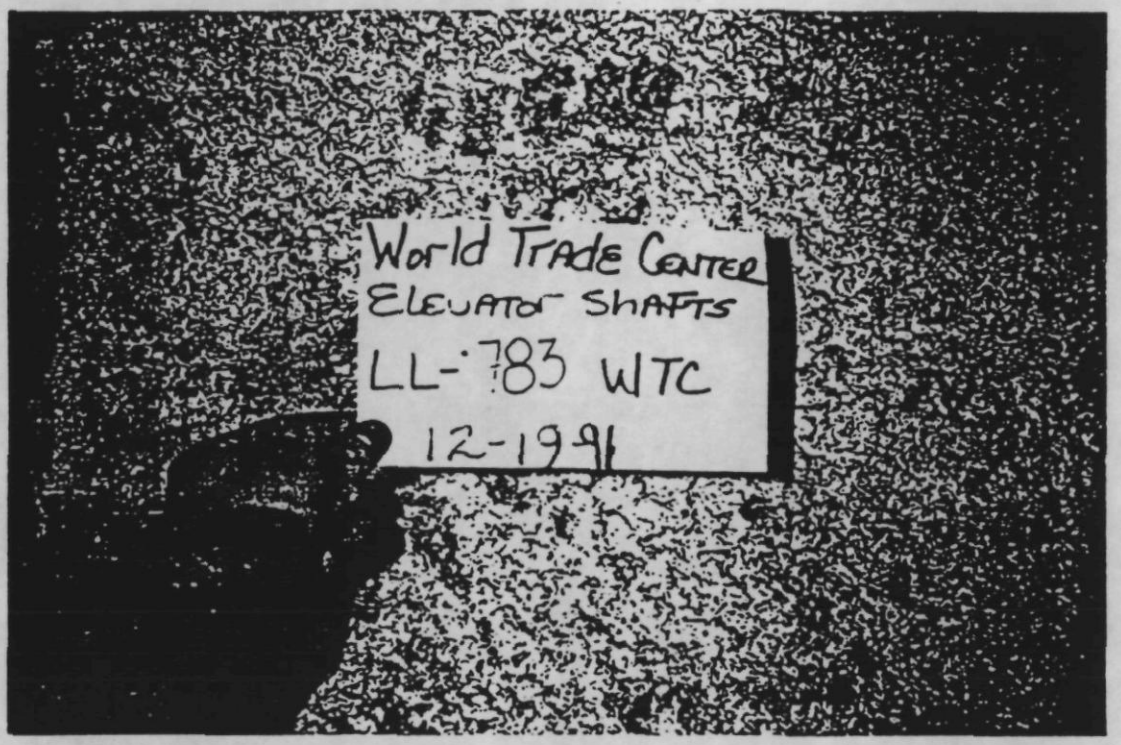
World Trade Center
Elevator Shafts
LL-783 WTC
12-1991

A. HARD Coat Encapsulant over fluffy spray-on.

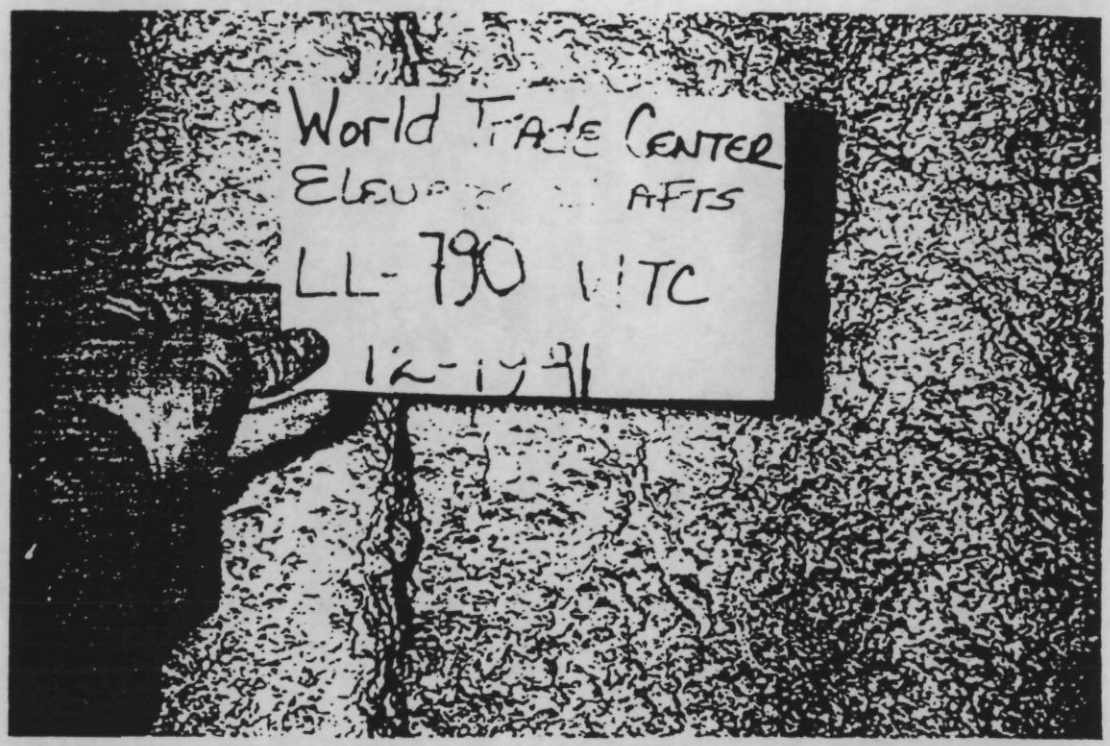
World Trade Center
LL-790 WTC
12-1991

-789-WTC	Spray-on fireproofing and hard coat encapsulant collected from Column #2 at the 45th floor. (Elevator Shaft Pe-63,64,65
LL-790-WTC	Spray-on fireproofing and hard coat encapsulant collected from Column #1 at the 66th floor. (Elevator Shaft Pe-66,67,68.)
LL-791-WTC	Spray-on fireproofing and hard coat encapsulant collected from Column #2 at the 46th floor (Elevator Shaft Pe-66,67,68)

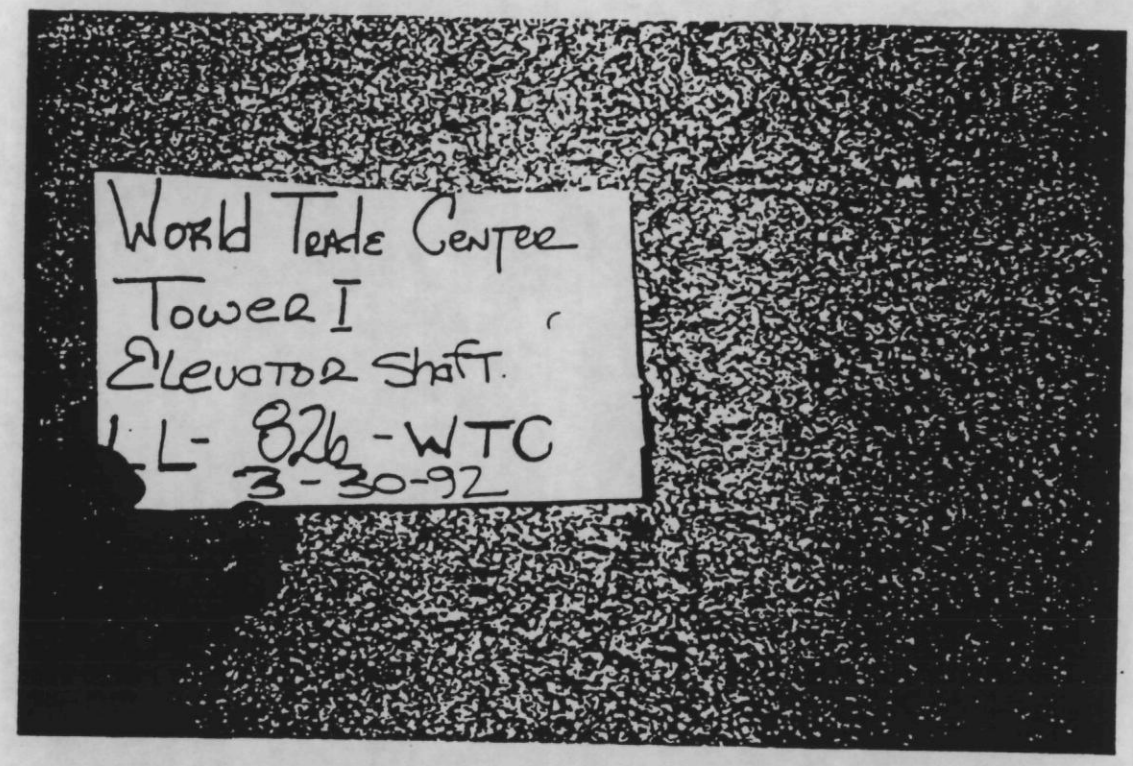
World Trade Center
Tower I
Elevator Shaft.
L- 826 - WTC
3-30-92

Comments: (Indicate any unique characteristics of the material which may help identify the manufacturer.)
HARD ENCAPSULANT applied over spray-on.

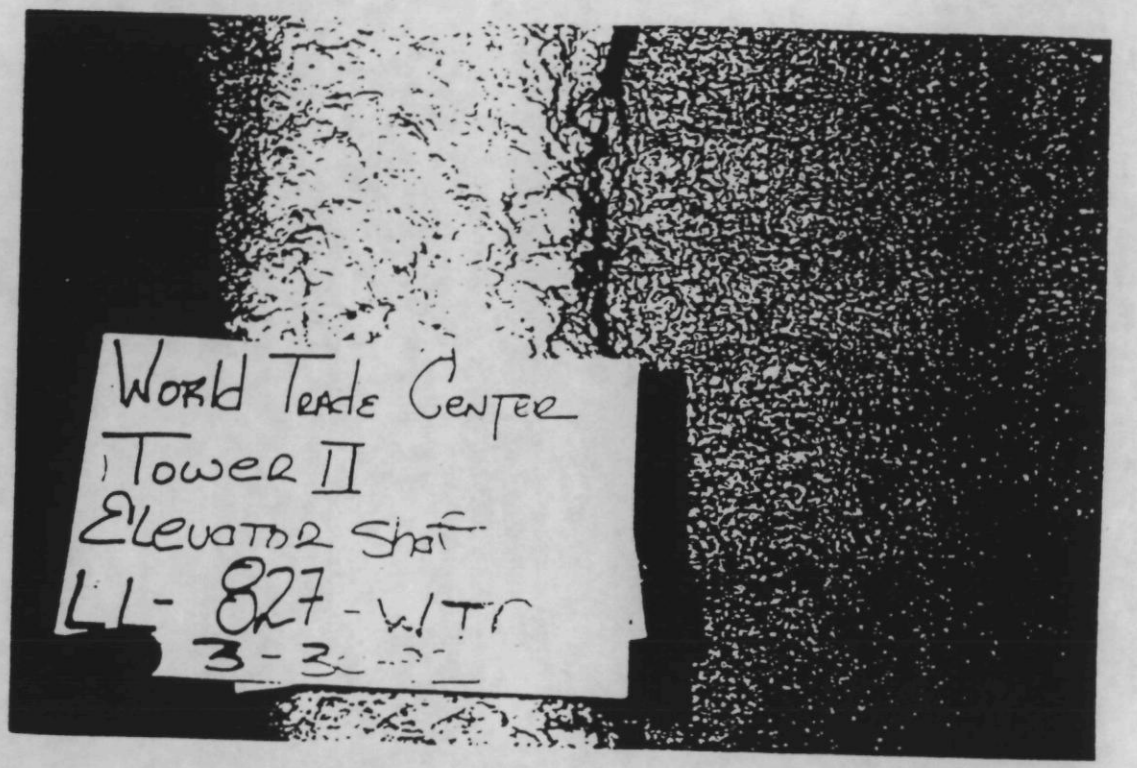
World Trade Center
Tower II
Elevator Shaft
LL - 827 - WTC

CE NUMBER	DESCRIPTION OF SAMPLING LOCATION
LL-827-WTC	Spray on fireproofing & Encapsulant mat'l Sampled from a (52") I-Column. Samples Collected from the 60th Floor, Column No. #1 CAR pe-68
LL-828-WTC	Spray on fireproofing & Encapsulant mat'l Sampled from a (52") I-Column. Samples Collected from the 45th Floor, Column No #2, CAR pe-68
LL-829-WTC	Spray-on fireproofing & Encapsulant mat'l Sampled from a (52") I-Column. Samples Collected from the 60th floor, Column No #1, CAR pe-57
LL-830-WTC	Spray-on fireproofing & Encapsulant mat'l Sampled from a (52") I-Column. Samples Collected from the 45th floor, Column No #2, CAR pe-57

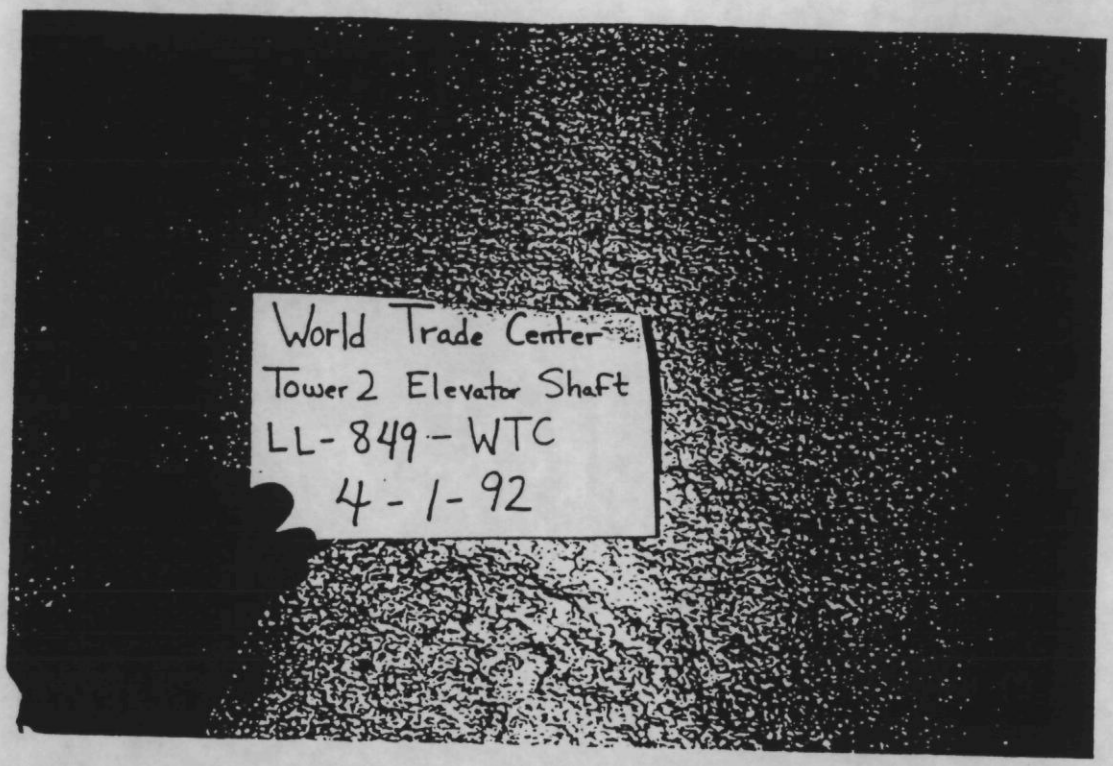
World Trade Center
Tower 2 Elevator Shaft
LL-849-WTC
4-1-92

The material was encapsulated with a distinct, detectable hard outer coat that is included in our samples.
